Birdbaths on Concrete Slabs

ASCC Position Statement #7

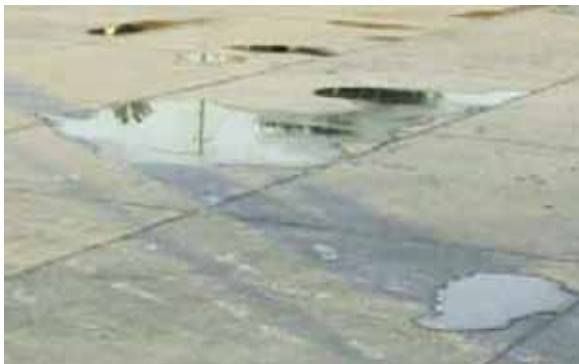
Eliminating birdbaths would require zero tolerances. The adjacent figure shows a birdbath at the

valley of a slab surface profile under a 10 ft. straightedge. The tolerances shown are from ACI 117 and would indicate the maximum depth of the birdbath.

Expecting or requiring no birdbaths on level or sloped slabs is not compatible with ACI 117 tolerances. Specifying a relatively large permissible gap under a straightedge (low FF) results in numerous deep birdbaths. Specifying a small gap under a straightedge (high FF) results in a few shallow birdbaths.
